이축연신 폴리프로필렌 필름 Capacitor의 Grape-clustering Process에 관한 연구

Grape-clustering Process of BOPP Film Capacitors

Kwang S. Suh and Chathan M. Cooke*

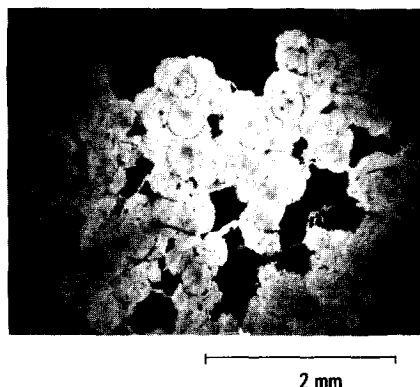
Fig. 1. Grape-cluster from the failed film capacitor: 6 μm thick BOPP film with Zn-metallization.

Lab grape-clusters (Figure 3) have every feature found in failed roll capacitors (Figure 1). The major difference is the size of single events, possibly due to the difference in the voltage levels between two experiments.

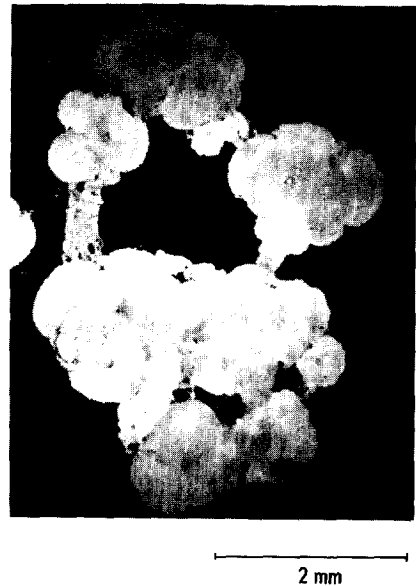
Fig. 3. Grape-cluster from lab test system : $6\text{ }\mu\text{m}$ thick BOPP film with Zn-metallization, 5.77 ohm/square , lab air, $700\text{ V}_{\text{rms}}$.

A typical morphology of electrode erosion obtained from a lab scale acceleration tests is shown in Figure 3. The voltage applied was $700\text{ V}_{\text{rms}}$ in a lab air condition and the sample was the Zn-metallized BOPP film. A large area of electrode erosion resulted from the application of ac stress. Each circular area (single event) has a puncture at the center and irregular shaped erosion around the puncture the average size of which is approximately 0.7 mm in this particular case. Also, many interchannels between each single event were observed.

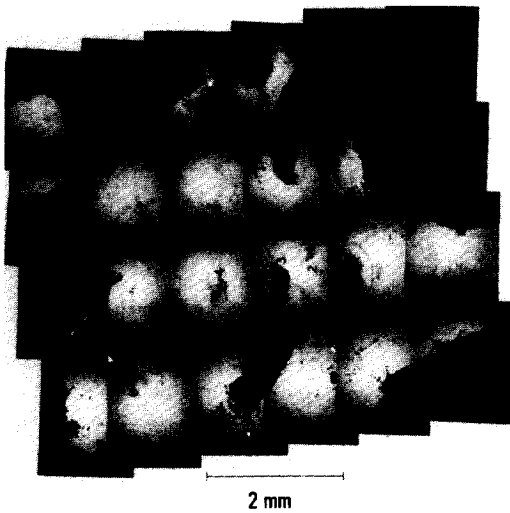
Fig. 4. Lab grape-cluster showing a large area of electrode erosion : 6 μm thick BOPP film with Al-metallization, 2.2 ohm/square, lab air, 3.8 kV_{dc}.

ter several current pulses were detected. This test was done under dc voltages. A typical lab grape-cluster showing a large area of electrode erosion is shown in Figure 4. In this figure one can notice that most events have a severely damaged spot near the puncture, blasting either radially or towards only one direction. Circular erosion # 1 has a puncture at its center and another puncture at its perimeter. After this, one fan-shaped erosion is found, which is followed by an electrode erosion with the puncture #3. Two streams of the consecutive electrode erosion resulting in a massive electrode erosion are identifiable : one grows from # 1 to # 6 (# 1→# 2→# 3→# 4→# 5→# 6) and the other from # 1 to # 9 (# 1→# 2→# 3→# 7→# 8→# 9). From this figure it can be seen that most punctures except the one marked by # 1 are developed mostly at the edge of perimeter erosion and that a large area of electrode erosion is resulted from many fan-shaped erosions.

With the assistance of the result shown in Figure 5, it may be reasonable to conclude that the large area of electrode erosion in Figure 4 was caused by the circular erosion marked by # 1 and propagated into a large area by the rest of events marked # 2 to # 9.

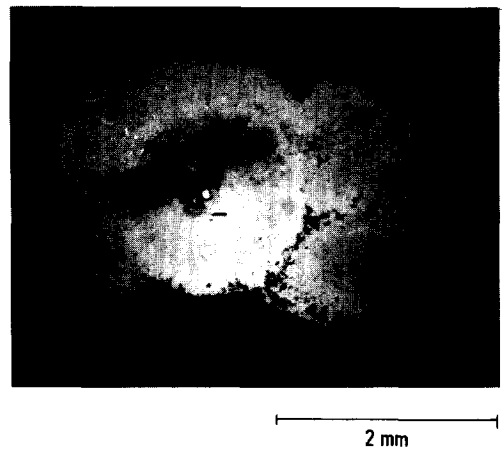
Regarding the sequence of electrode erosion, Figure 5 is more informative. The specimen for this picture was taken out of the test chamber after a series of current pulses at 3~4 kV_{dc}. A circular erosion marked by # 1 has three perimeter ero-

Fig. 5. Electrode erosion after a series of current pulses : 6 μm thick BOPP film with All-metallization, 2.2 ohm/square, lab air, 700 V_{rms}.

sions. At the edge of erosion # 2, another puncture having a fan-shaped perimeter expansion is observed.

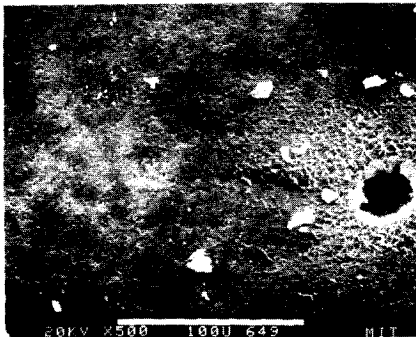
by a discharge event is in Figure 6. Test films with the Al-metallization under ac voltages show some haziness at the polymer surface. Under the SEM, as shown in Figure 7, it has been proved that a bunch of mechanical pits are on the order of sub-micron. Mechanical pits were found all over the polymer surface of all samples regardless of the type of metallization.

Fig. 6. Damage morphology at the polymer side.

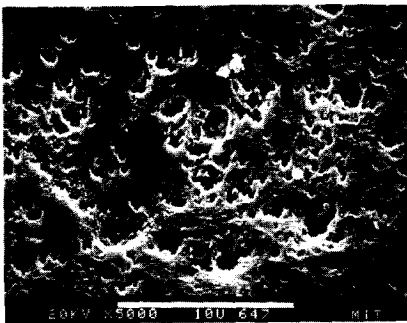
Fig. 7. Enlarged picture at the remote region.

puncture leading to the grape-cluster shows a irregular shaped erosion whereas that leading to the clearing event shows a regularly shaped (circular) erosion. Around the puncture site, there is a severely damaged region extended to some distance which was observed to depend on the type of metallization. This damage looks like the melting of the polymer surface. Lots of mechanical pits were around. The average size of such damages around the puncture site are different depending on the type of metallization. They are about 50 and 300 μm in diameter for Al and Zn, respectively. The remote region outside a severely damaged region is believed to be apparently not damaged, but has a lot of mechanical pits of an order of submicron in diameter.

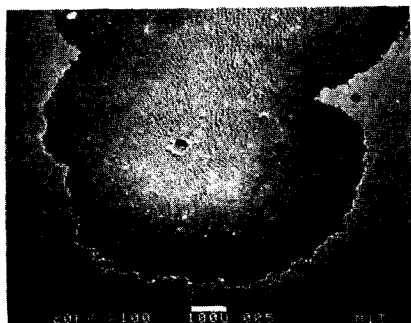
Metallization Side : Damage morphologies at the metallization side are shown in Figure 9 and 10 for the Zn-metallization. Damage morphology under ac voltages is almost the same for all types of metallization.

Fig. 9. Damage morphology at the metallization side.

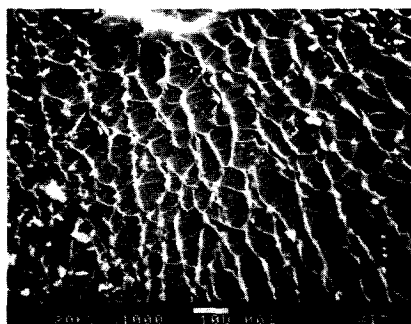
Fig. 10. Enlarged picture near the puncture.

A schematic representation for these regions is in Figure 8. The puncture is, as mentioned, a physical removal of the base polymer. The size of puncture seems to be almost the same, roughly $30\ \mu\text{m}$ in diameter, for all metallizations. There is a severely damaged region the size and shape of which also depend on the type of metallization. Figure 10 shows that the damage in this region was propagated radially to a long distance up to a few hundred μm . Separate tests with the Zn-metallization yielded the same type of damage with a little smaller size (250 and $400\ \mu\text{m}$ for the Zn and Al-metallizations, respectively). The remote area is the region between the edge of the severely damaged area and interface with the electrode. In this region, the metallization is removed as a result of
