이축연신 폴리프로필렌 필름 Capacitor의 Grape-clustering Process에 관한 연구

Grape-clustering Process of BOPP Film Capacitors

Kwang S. Suh and Chathan M. Cooke*

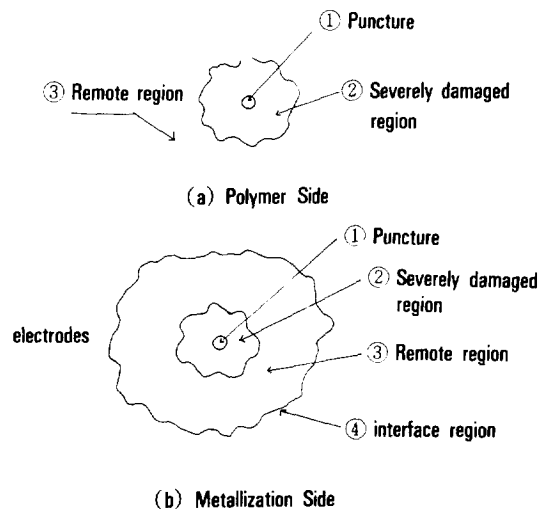
Fig. 8. Schematic representation of damaged area.

- (1) puncture site,
- (2) severely damaged region, and
- (3) remote region.

These are schematically shown in Figure 8, along with those for the metallization side. The puncture is obviously a big damage which removes certain amount of polymeric material. Throughout many tests, it has been found that the shape of

Generally the damaged area of the metallization side is classified into four regions :

- (1) the puncture site,
- (2) severely damaged region,
- (3) remote region, and

A schematic representation for these regions is in Figure 8. The puncture is, as mentioned, a physical removal of the base polymer. The size of puncture seems to be almost the same, roughly $30\ \mu\text{m}$ in diameter, for all metallizations. There is a severely damaged region the size and shape of which also depend on the type of metallization. Figure 10 shows that the damage in this region was propagated radially to a long distance up to a few hundred μm . Separate tests with the Zn-metallization yielded the same type of damage with a little smaller size (250 and $400\ \mu\text{m}$ for the Zn and Al-metallizations, respectively). The remote area is the region between the edge of the severely damaged area and interface with the electrode. In this region, the metallization is removed as a result of
